# LOVING YOUR BOAT TO DEATH.

WORDS: Chris McMullen and Baden Pascoe

Apart from fresh water ingress, electrochemical destruction of hull timbers is the biggest threat to our classic boat fleets.

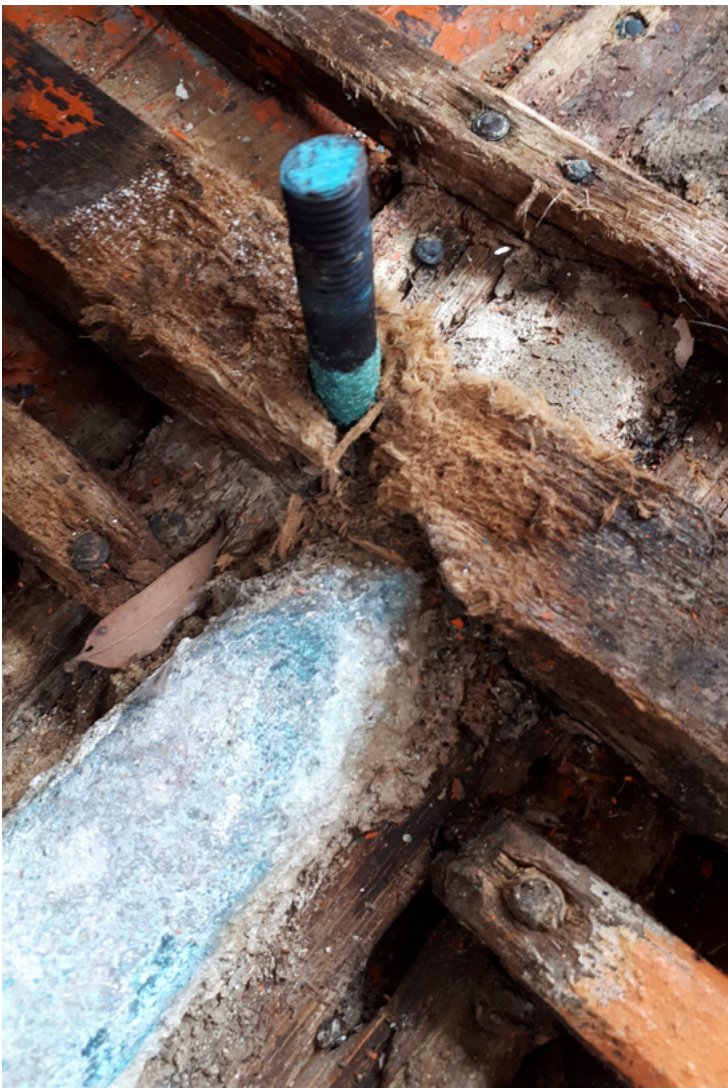
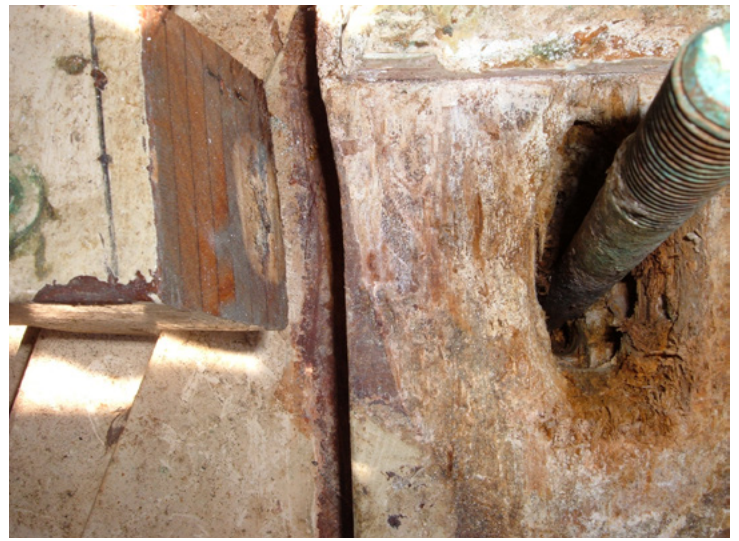
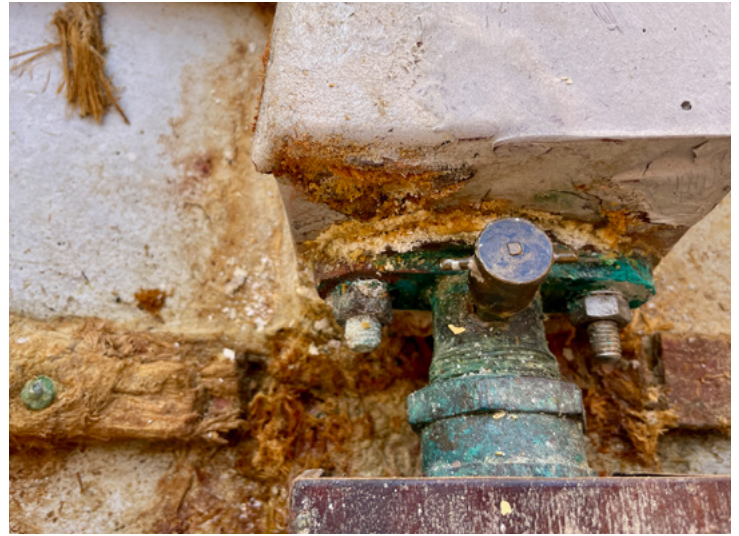
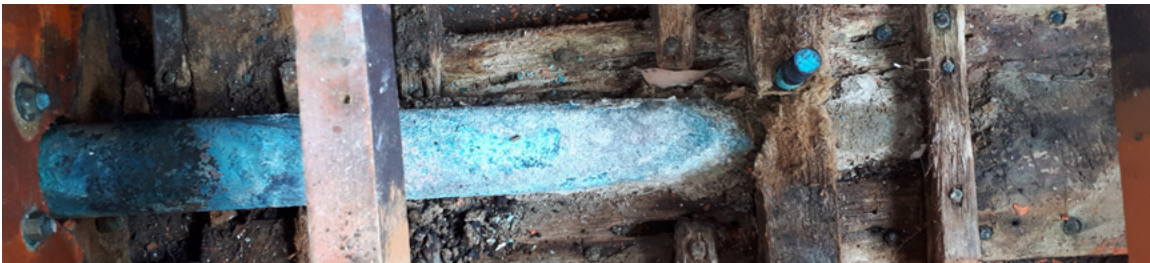
Some good examples of electrochemical destruction to timbers.

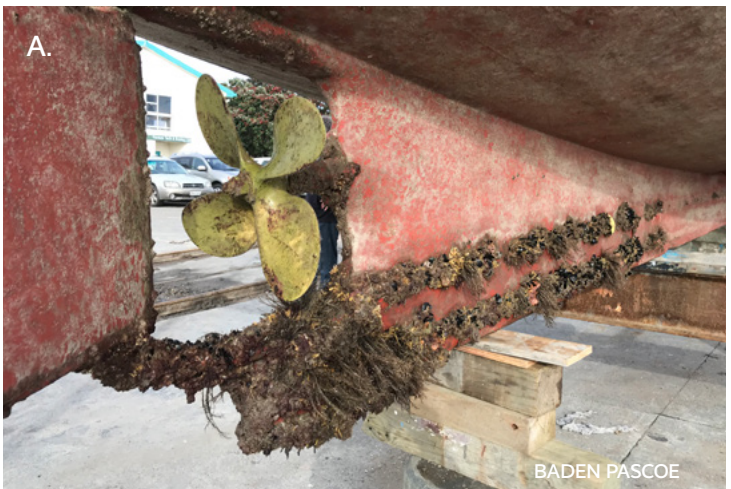
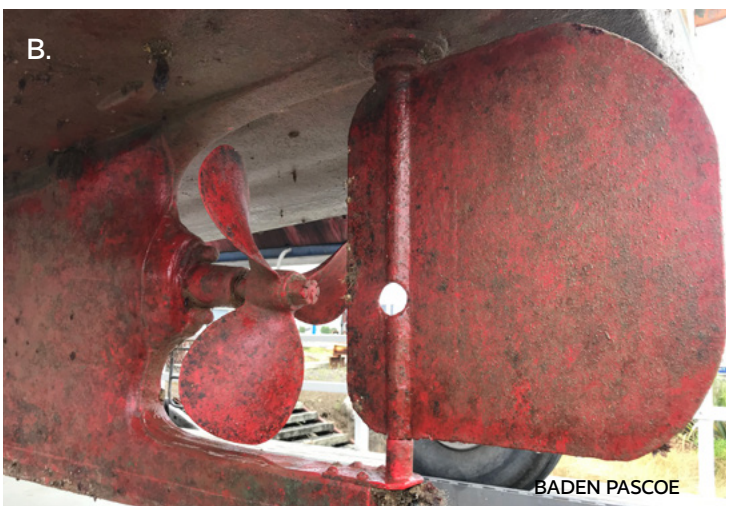
A good example of the use of similar metals. No anodes required.

1. If all underwater metal parts are of the same material—for example made from one of the marine bronze materials—no anodes are necessary. Some say, “*but I have a stainless steel drive or rudder shaft*”. Then insulate the prop with PropSpeed and the potential is not worth worrying about. Many wise wooden boatowners have adopted this concept and have had absolutely no further issues
